The GPS synchronization challenges during the development, construction and installation of a measurement system for multi-point, high-speed and long-term data logging is described in this paper. The presented measurement system was tested in a rough offshore environment at Avedøre Holme (see Figure 1) and Gunfleet Sands Offshore wind farms. The paper will describe the application of GPS technology in synchronised measurements carried out at Avedøre Holme and Gunfleet Sands wind farms. Different aspects of software development and hardware configuration in order to optimise measurement system reliability during offshore measurements will be presented. Also real-life examples of results from both offshore measurement campaigns will be described. Some limitations and improvements of the measurement system will be explained based on measurements from both harmonic and transient measurements.

Gunfleet Sands Offshore Wind Farm

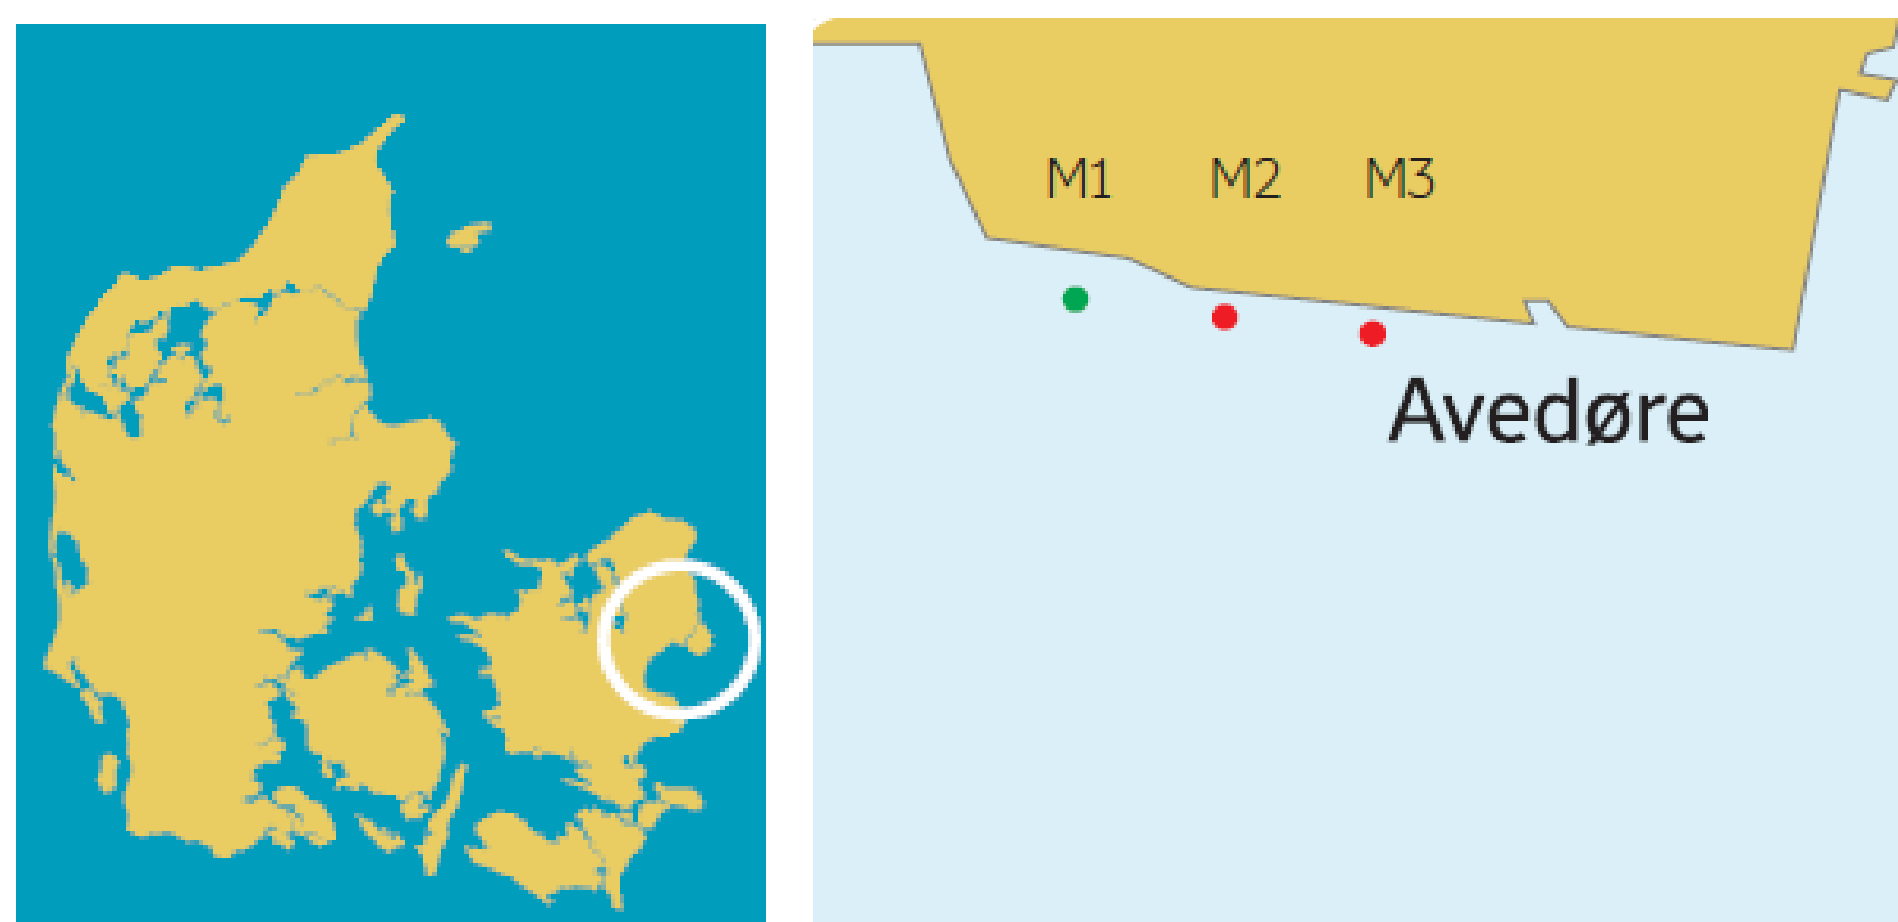
Figure 1 Avedøre Holme Offshore Wind Farm and measurement points.

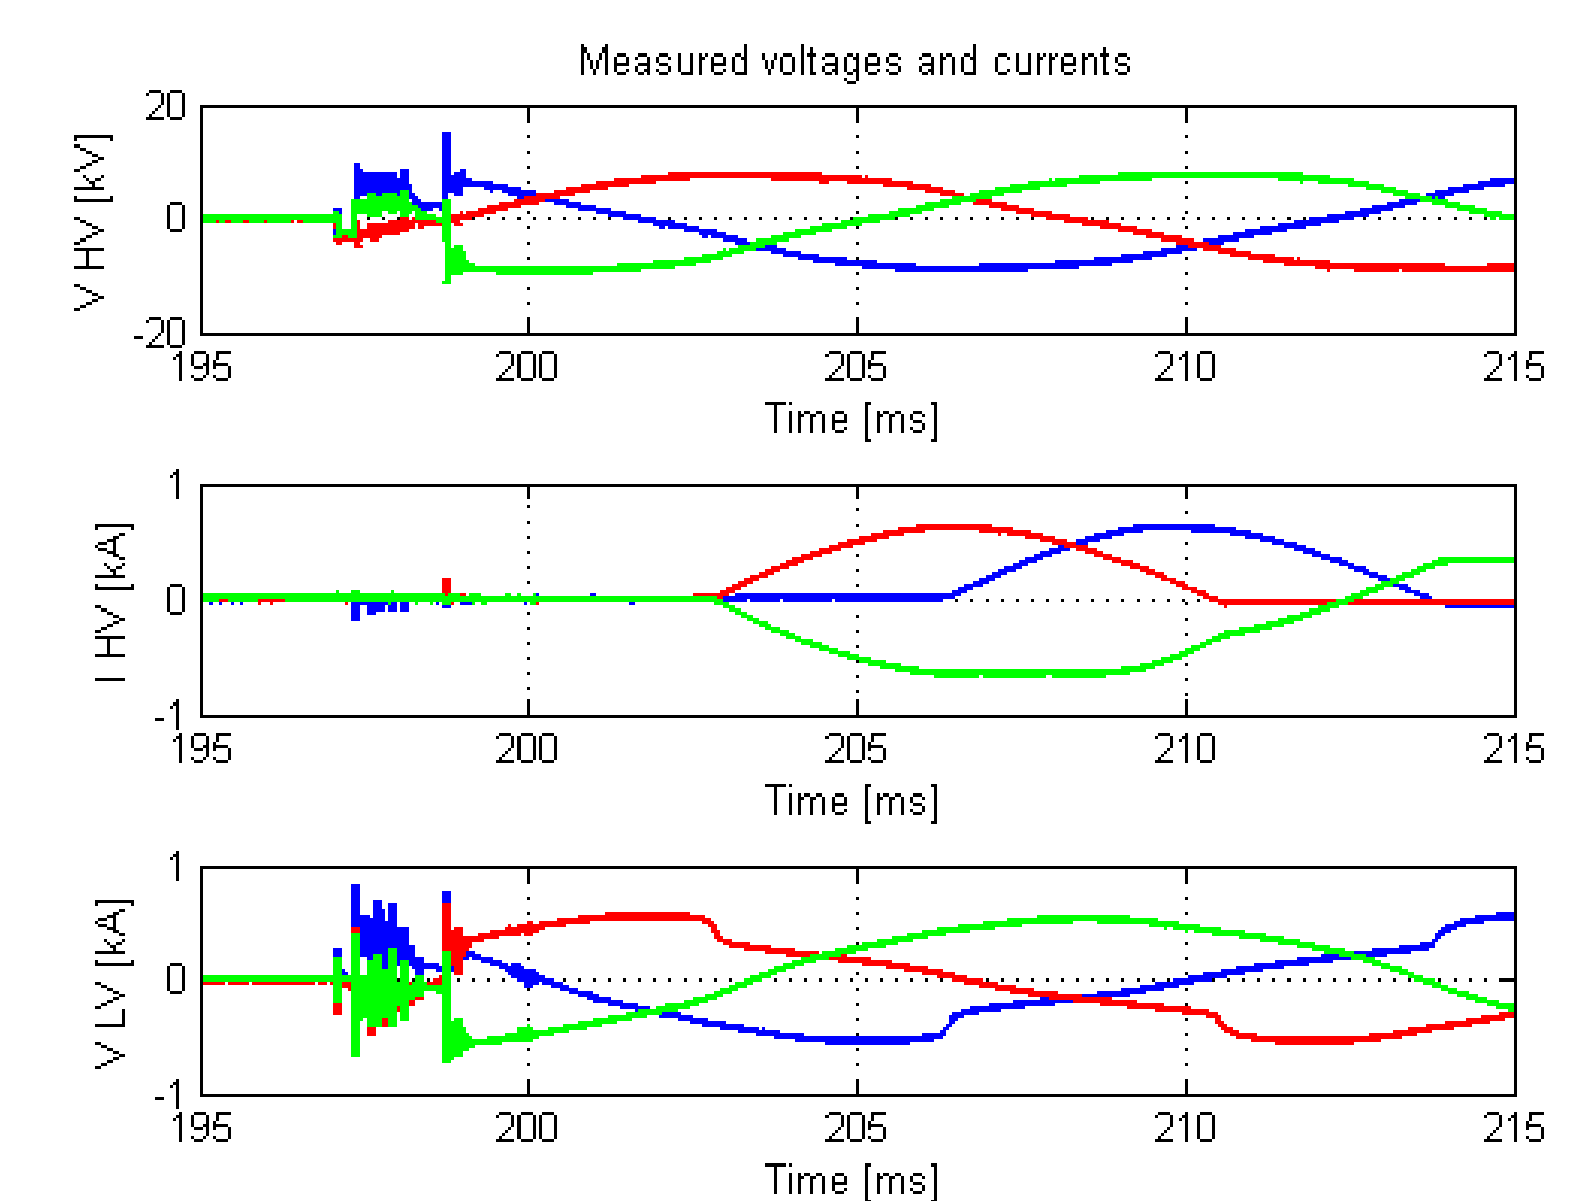
Some of the transient measurements during the switching in of the VCB in the AVV wind turbine are shown in Figure 3. In this figure the voltage and current on the MV side of the transformer are shown, as well as the LV side voltage. It is possible to see in this figure the high frequency voltage oscillation caused by the pre-strike in the VCB that is transfer to the LV side as well as the inrush current of the transformer. The VCB model validation, as well as the wind turbine transformer and external grid validation has been reported in [7].

Figure 3 Measured three-phase voltages and currents, during the closing operation of the MV VCB in the wind turbine.
