Abstract

The GPS synchronization challenges during the development, construction and installation of a measurement system for multi-point, high-speed and long-term data logging is described in this paper. The presented measurement system was tested in a rough offshore environment at Avedøre Holme (see Figure 1) and Gunfleet Sands Offshore wind farms. The paper will describe the application of GPS technology in synchronised measurements carried out at Avedøre Holme and Gunfleet Sands wind farms. Different aspects of software development and hardware configuration in order to optimise measurement system reliability during offshore measurements will be presented. Also real-life examples of results from both offshore measurement campaigns will be described. Some limitations and improvements of the measurement system will be explained based on measurements from both harmonic and transient measurements.

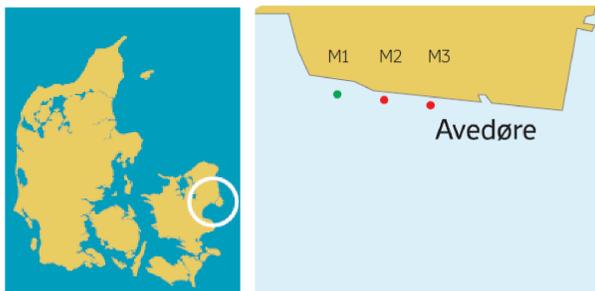
Figure 1 Avedøre Holme Offshore Wind Farm and measurement points.

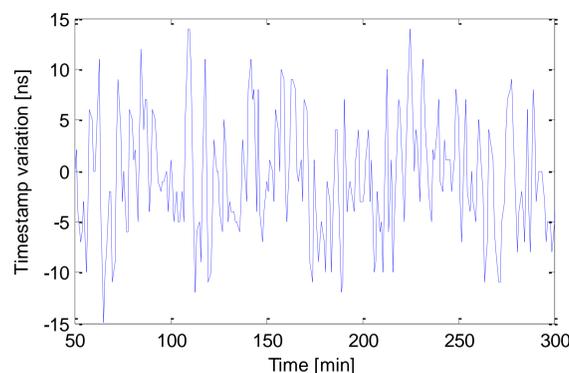
Pulse-per-second signal accuracy measured during measurement campaign at Gunfleet Sands OWF is shown in Figure 2. The accuracy is even better than provided by the manufacturer (15 ns, 1σ).

Figure 2 Variation of pulse-per-second signal synchronized with a GPS timestamp using phase-locked loop

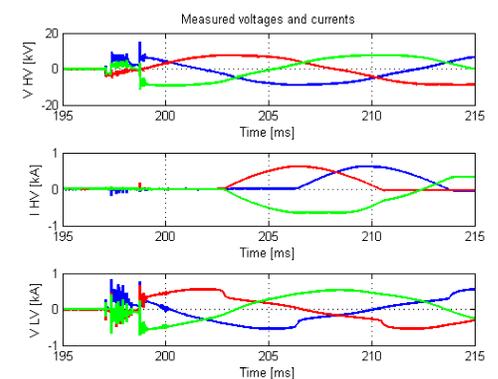
Some of the transient measurements during the switching in of the VCB in the AVV wind turbine are shown in Figure 3. In this figure the voltage and current on the MV side of the transformer are shown, as well as the LV side voltage. It is possible to see in this figure the high frequency voltage oscillation caused by the pre-strike in the VCB that is transfer to the LV side as well as the inrush current of the transformer. The VCB model validation, as well as the wind turbine transformer and external grid validation has been reported in [7].

Figure 3 Measured three-phase voltages and currents, during the closing operation of the MV VCB in the wind turbine.
